**Multi – Agency
Serious Accident Review Team**

Floyd – Roselle Incident

Final Report

City of Modesto Public Works Department

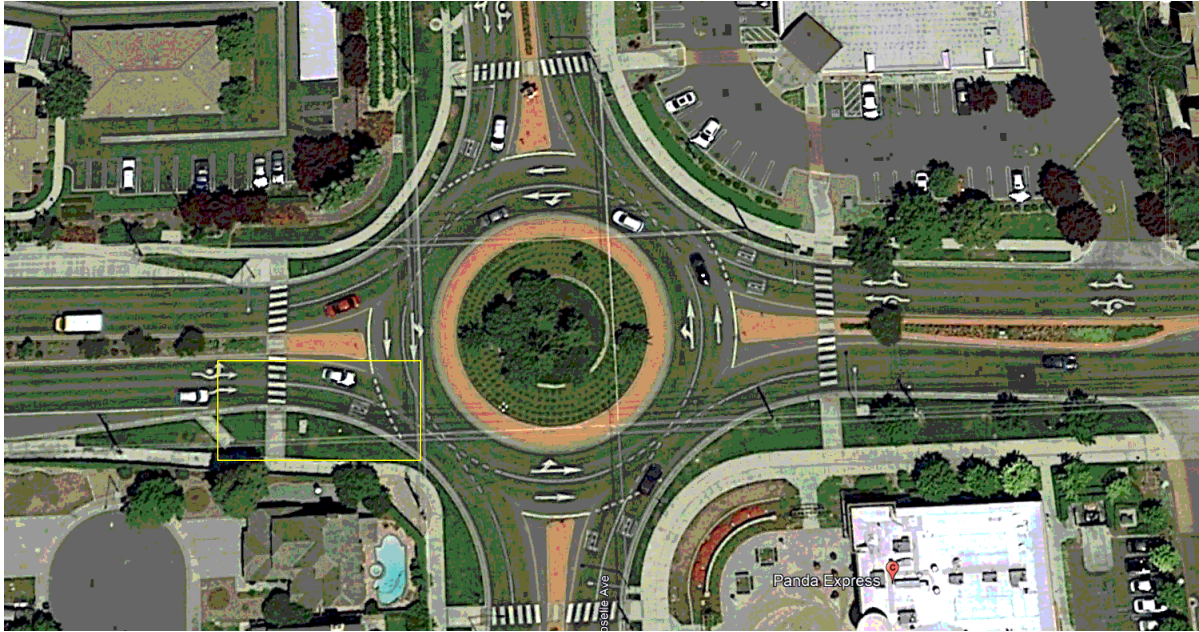
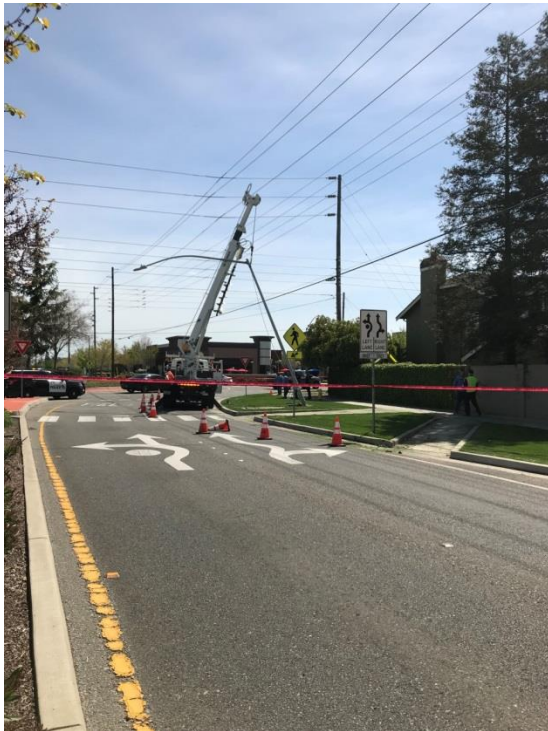
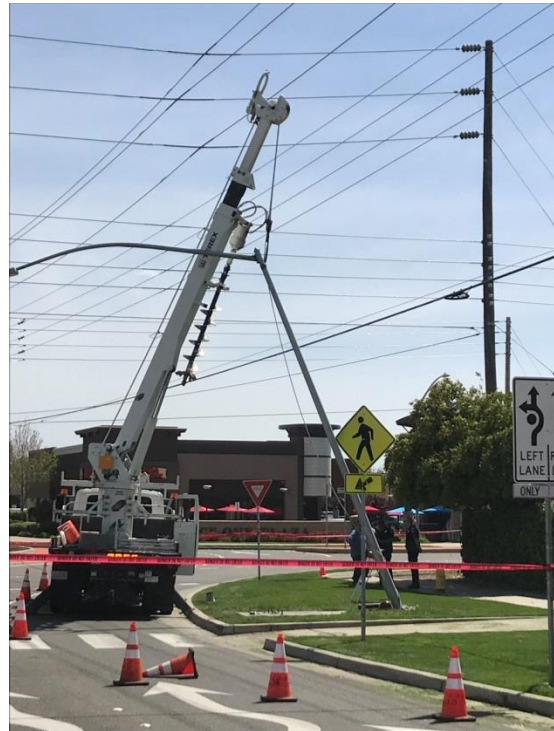
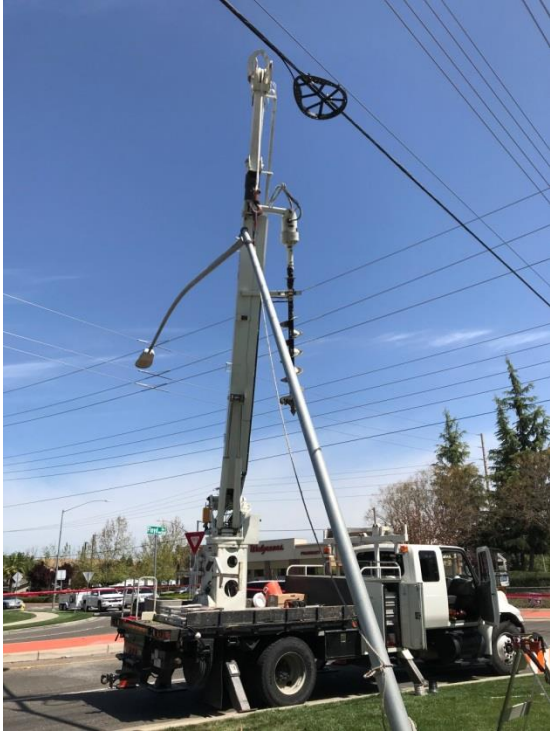
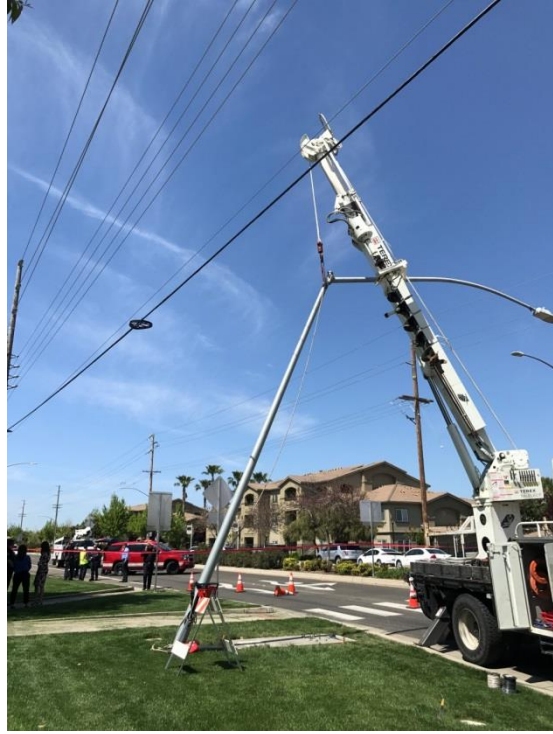
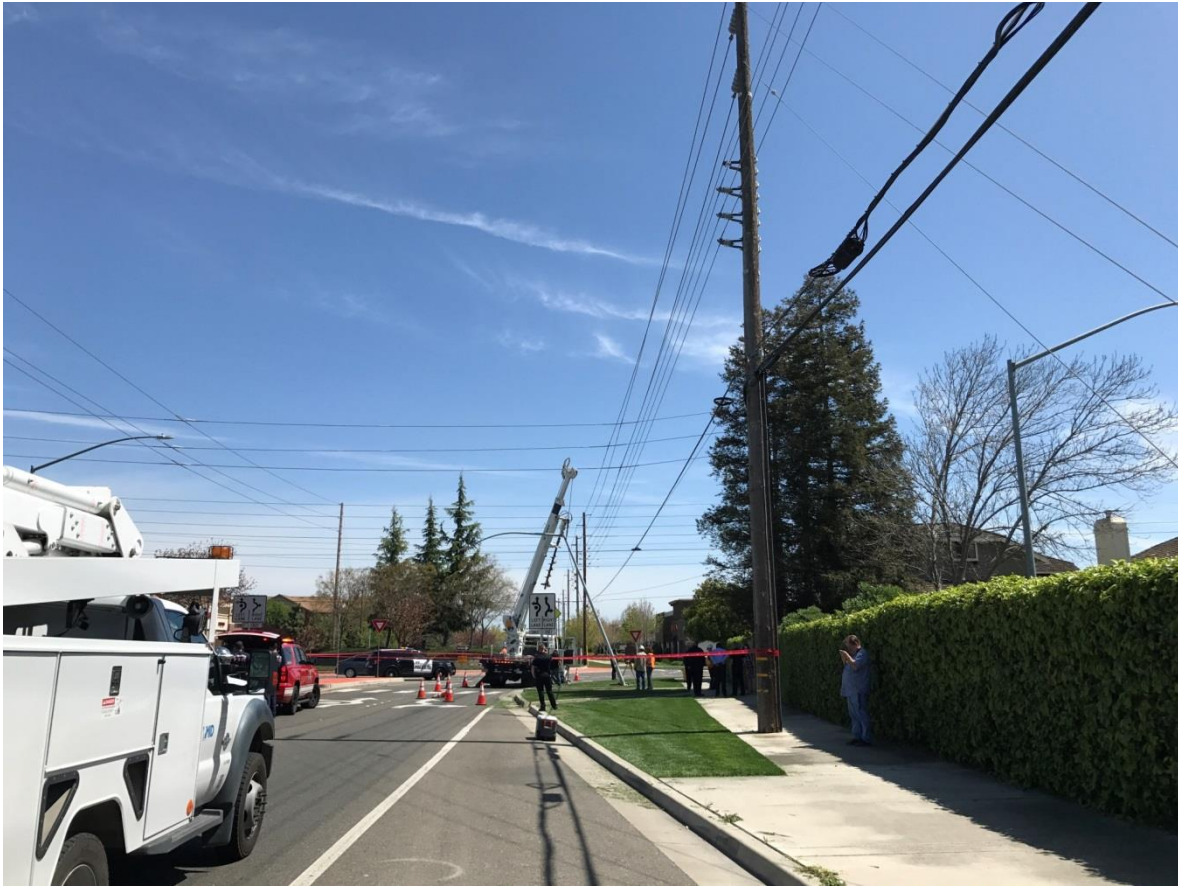
The site involved is located at Southwest corner at Floyd Ave and Roselle Ave. The City's Digger Derrick was parked on the same corner facing East on the number two lane. The street was blocked off approximately 35 feet behind the Digger Derrick for installation of the light pole. See picture below.
